MEADOW RESTORATION INCREASES BASE FLOW AND GROUNDWATER STORAGE IN THE SIERRA NEVADA MOUNTAINS OF CALIFORNIA

Luke J.H. Hunt, Julie Fair and Maxwell Odland

Department of Conservation (Hunt, Fair), American Rivers, 120 Union Street, Nevada City, California 95959, USA; Department of Plant Sciences (Odland), University of California, Davis, One Shields Ave. Davis, California, 95616, USA. (Correspondence to Hunt: lhunt@americanrivers.org).

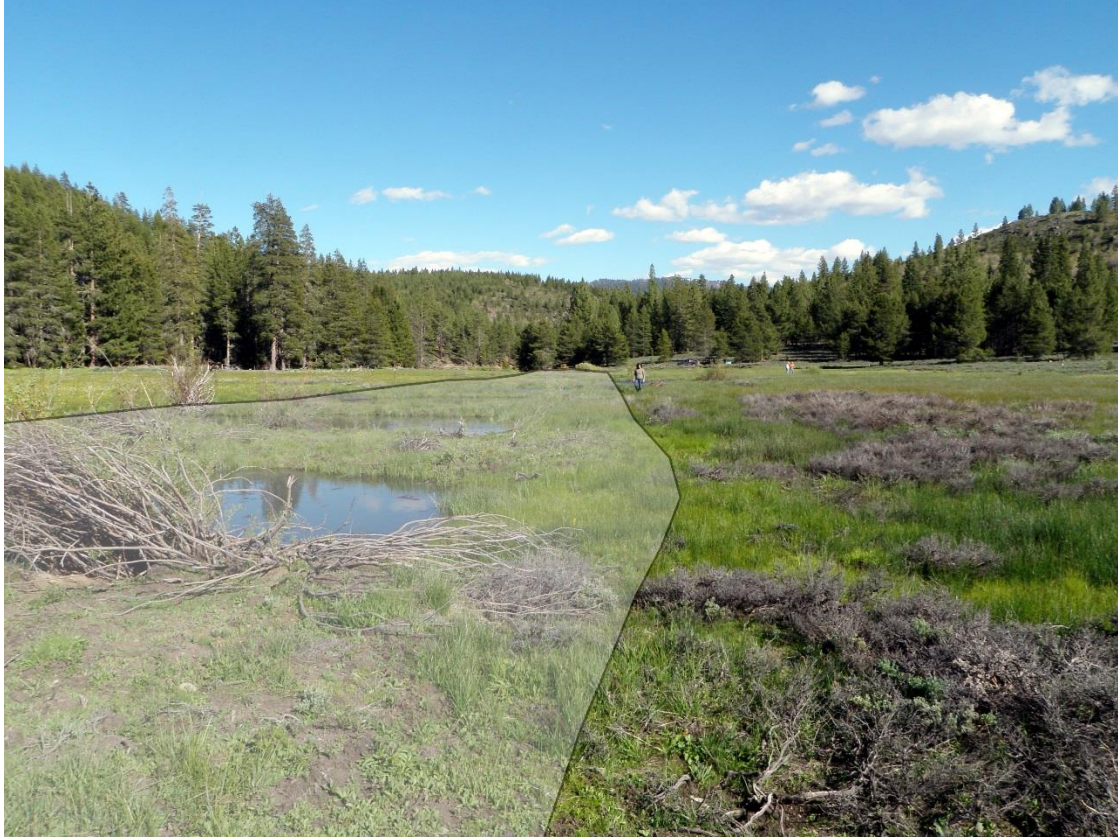
Figure 1. The incised channel (shaded at left) was filled using the plug and pond method in this meadow north of Lake Tahoe. Before restoration, well-drained banks supported sagebrush (shrub skeletons at right). Overbank flooding is now common; the summer water table is near the meadow surface and wet meadow vegetation is replacing sagebrush.

Various methods have been used to raise the bed elevation of incised channels through mountain meadows, including filling an incised channel with earth, either entirely or in sections (termed plug and pond, Figure 1), constructing check dams or brush dams, and encouraging beaver dams (NRCS 2003, Pollock *et al.*, 2014). Throughout the western United States, state, federal and private sources are investing millions of dollars annually to repair incision and reconnect meadow floodplains.
